**SIASCONSET COASTAL BANK
STABILIZATION AND BEACH
PRESERVATION PROJECT
ALTERNATIVES ANALYSIS**

SEPTEMBER 2010

OCC Project # 210019

SIASCONSET BEACH PRESERVATION FUND, INC.

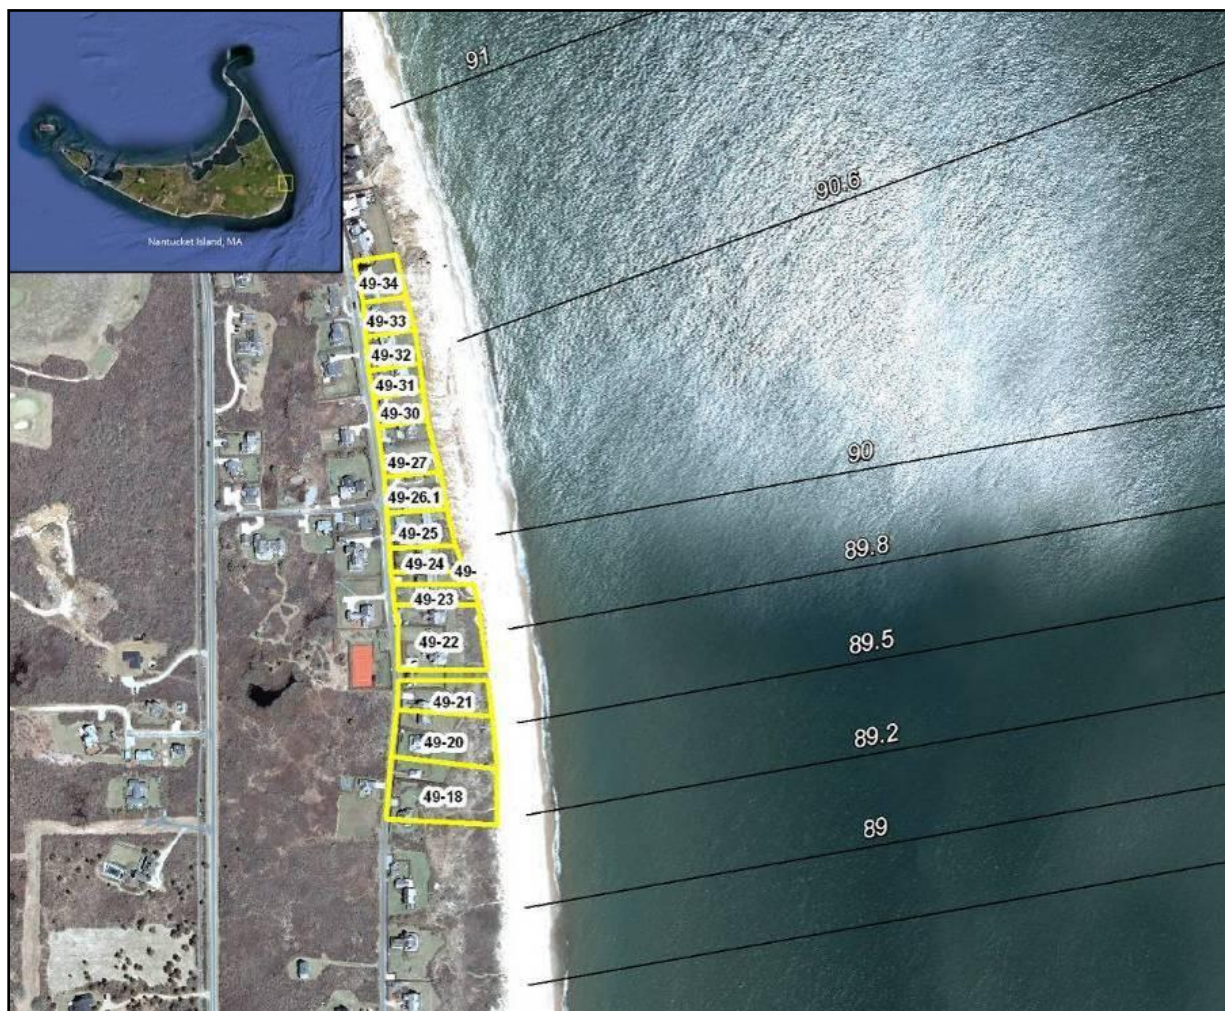
Figure 1 - Aerial image of Nantucket Island and the project extents with property numbers and profile lines.

The project site is located on the eastern shore of Nantucket Island, Massachusetts. The proposed project is for coastal bank stabilization along an east facing portion of coast adjacent to fourteen (14) privately owned residential properties. Currently, the project plan is to stabilize the bottom of the coastal bank using either a geotextile tube alternative or marine mattresses with gabion toe protection alternative. The coastal area to be protected is bound on the north by Lot #49-34 and on the south by Lot #49-18 and is approximately 1,700 linear feet in length. There are a total of 14 lots in the project area.

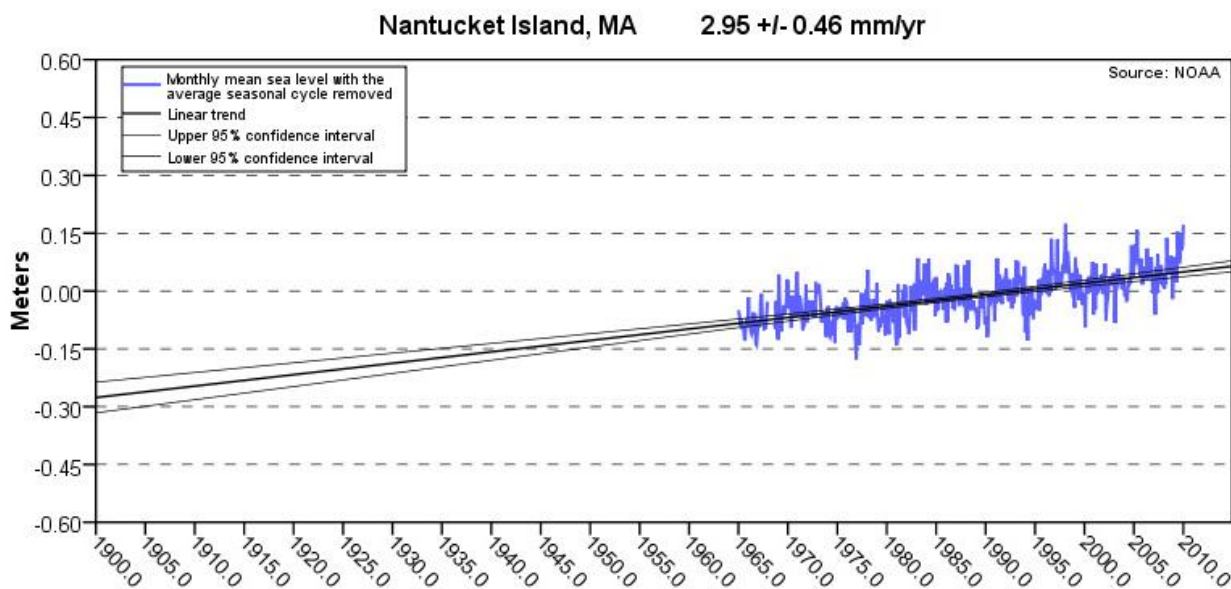
Figure 3 – Relative sea level rise trend for Nantucket, MA.

The plot shows the monthly mean sea level. The long-term linear trend is also shown, including its 95% confidence interval. The plotted values are relative to the most recent Mean Sea Level datum established by CO-OPS.

with a 95% confidence interval of +/- 0.46 mm/yr based on monthly mean sea level data from 1965 to 2006 which is equivalent to a change of 0.97 feet in 100 years.

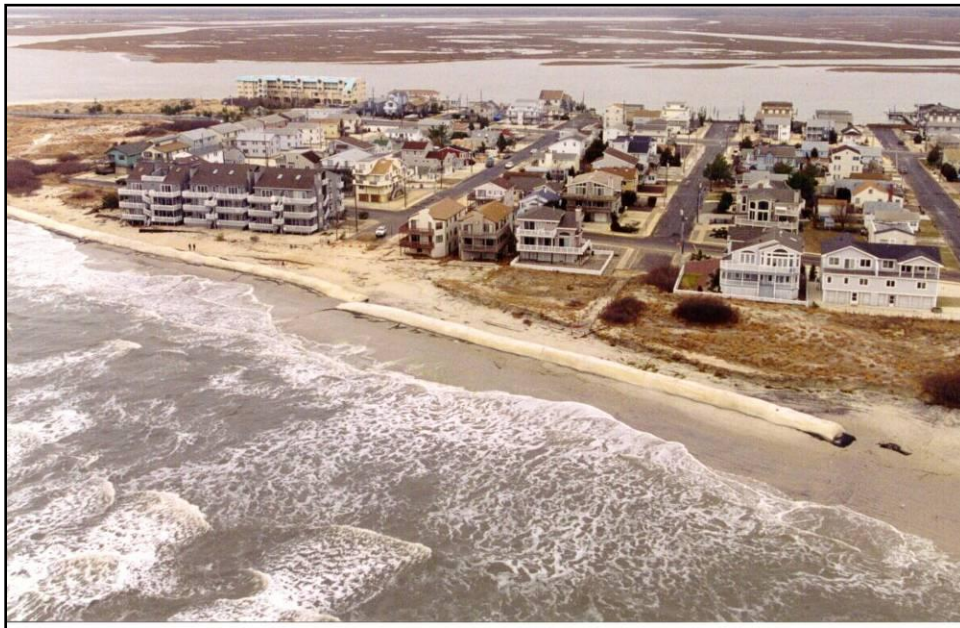
Figure 6 – Aerial view of geotextile tubes in Sea Isle City, NJ, 1998.

Geotextile tubes have been used extensively for shoreline protection projects. One example was the installation of three, 30-foot circumference tubes along an eroding stretch of beach in Sea Isle City, New Jersey in December of 1997 to protect an 18-unit apartment complex. The construction sequence included a one foot deep trench onto which a scour apron was placed, filling the tubes to a height of 5.5 to 6.0 feet (with a width of 12-13 feet) and covering with a one to two foot layer of sand cover. The resulting dune was approximately 8 feet high. Three months after the installation, the project area was hit with a Nor'easter and Cape May County was declared a national disaster area. The condominium complex protected by the geotextile tubes was not damaged.

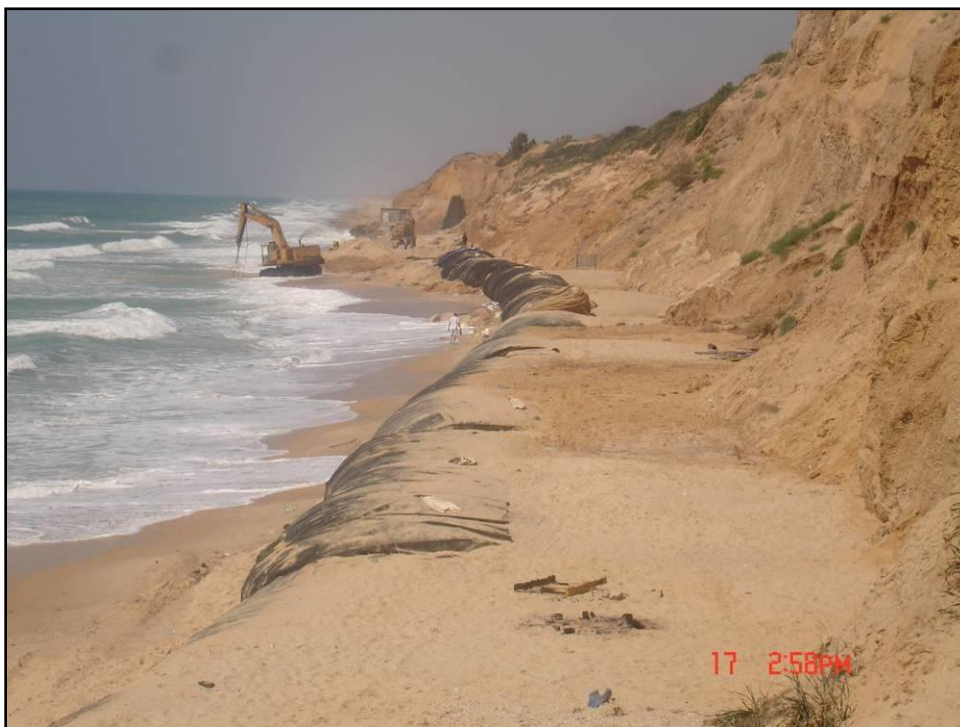
Figure 7 –Geotextile tubes at the base of the Ashkelon Cliffs, Israel.

Another example of geotextile tubes used for coastal protection is the installation of 40-foot circumference tubes to protect the toe of a coastal bluff at Ashkelon Cliffs, Israel subject to the full force of storm generated waves in the Mediterranean Sea. The tubes were installed at the base of sand bluffs approximately 40 to 50 feet tall to protect upland infrastructure. An image of the installed tubes is below in Figure 7 .

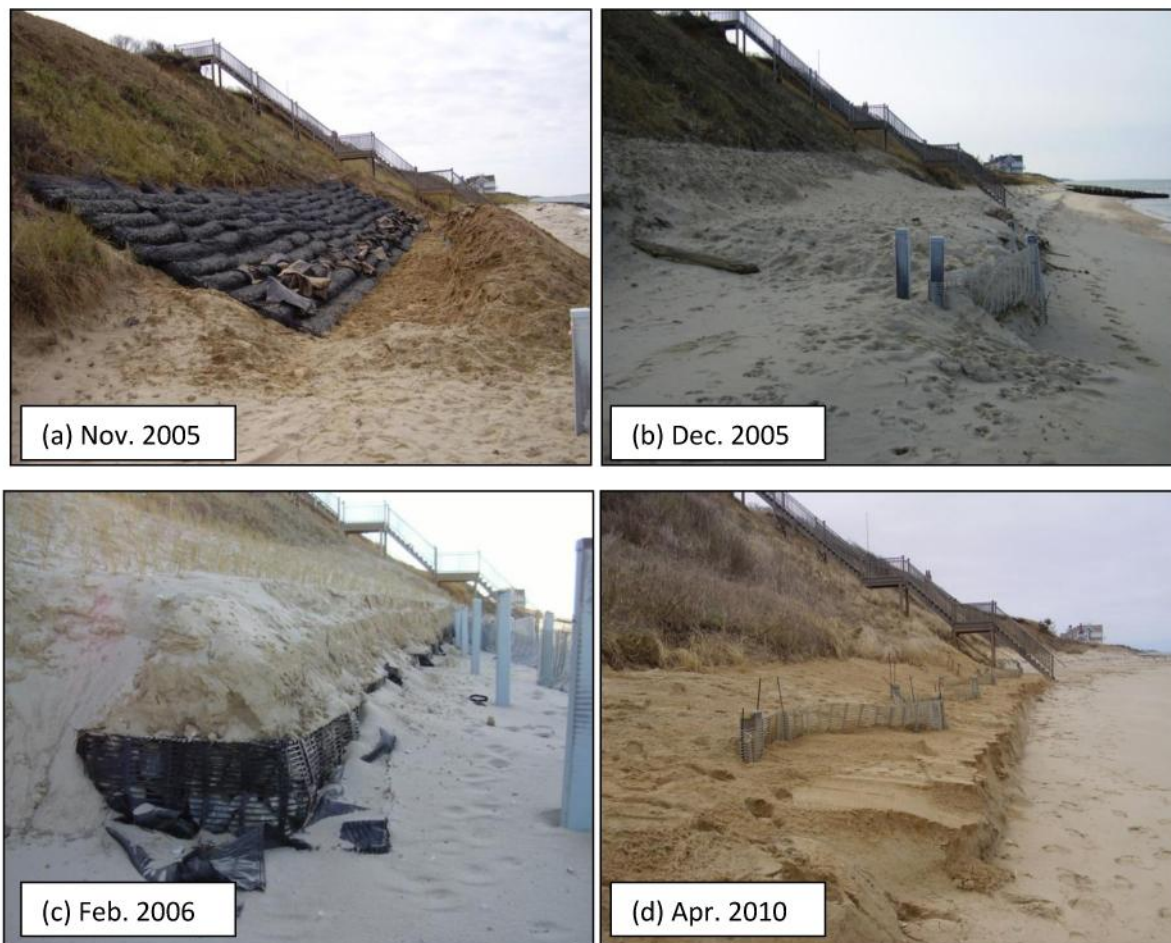
Figure 10 – View of a marine mattress with gabion toe coastal engineering structure permitted and installed at 28 Hinckley Lane, Nantucket (a) during construction, (b) after construction, (c) following coastal storm erosion, and (d) after annual nourishment to re-cover the marine mattress and gabion toe structure.

Similar coastal engineering structures have been installed in various locations around the world. One successful structure is located on the north shore of Nantucket Island at 28 Hinckley Lane, which was installed in 2005 and is performing very well. This design consisted of a row of 18 foot long buried marine mattresses placed along the toe of the coastal bank to prevent erosion from wave action. A vegetated dune was constructed over the marine mattresses to preserve the natural look of the property. This installation has been tested by several coastal storms. As shown in Figure 10, the storm waves erode the dune, which acts as a sacrificial sediment source to nourish the beach. The marine mattresses prevent the erosion from progressing any further, which would undermine the toe of the bank and cause subsequent slope failure of the upper bank. At the end of each winter season, the sacrificial dune is reconstructed over the marine mattresses.
